Energy Audits:

# Central Falls School District

Central Falls, RI 02863

Energy Audit Sponsored by:

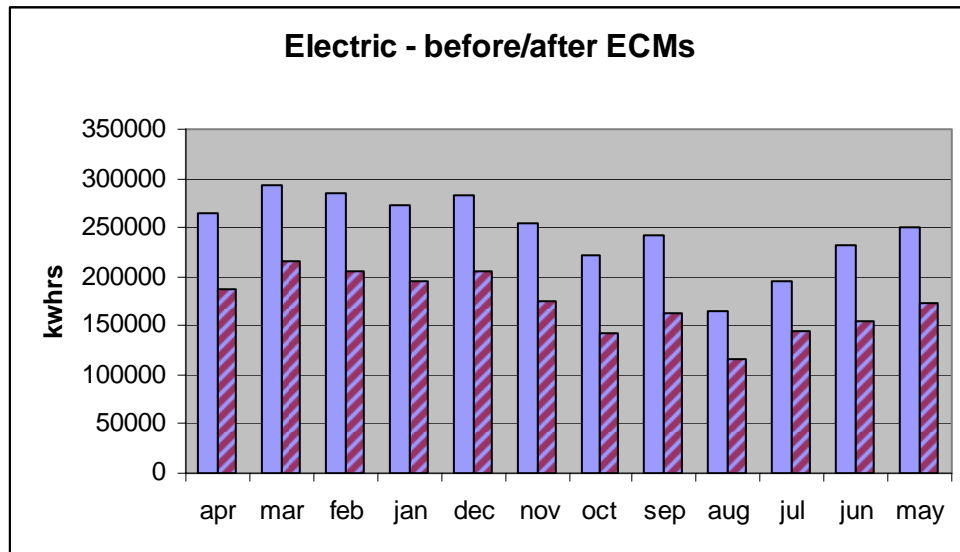
The following tables graphically indicate the projected savings in energy and demand if all the ECMs are installed:

Annually, this would be an estimated 30% savings in electric energy.

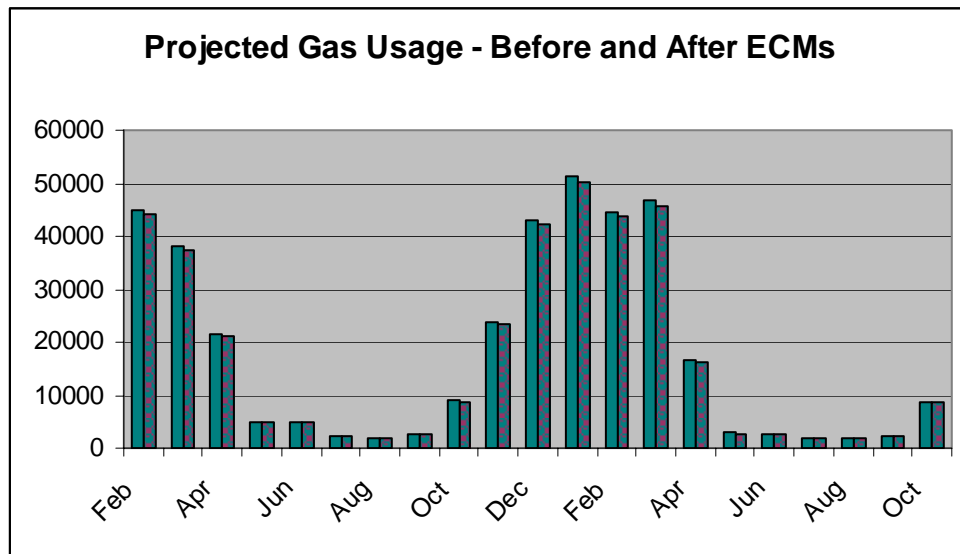
Annually, this would be an estimated 11% savings in gas usage.

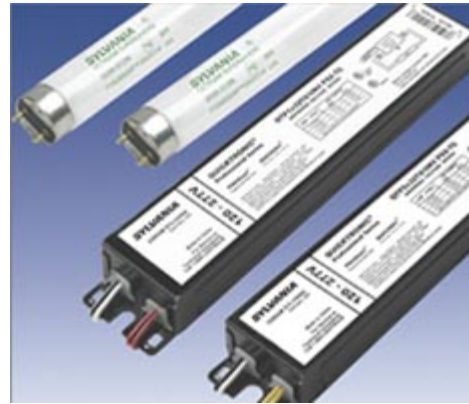
Fluorescent lighting has improved over time. Switching from standard T12 (1-1/2 inch diameter) fluorescent tubes with magnetic ballasts to thinner T8 tubes with electronic ballasts will save over 40 percent in electricity usage. Ballasts are an essential part of fluorescent lamps. Magnetic ballasts are now being phased out in favor of more energy-efficient electronic ballasts. Electronic ballasts have different starting characteristics depending on the specific use. These include rapid start, instant start, and program start varieties. Rebates from Narragansett Electric Company (NGRID) may be available for selected equipment with pre-approved applications.

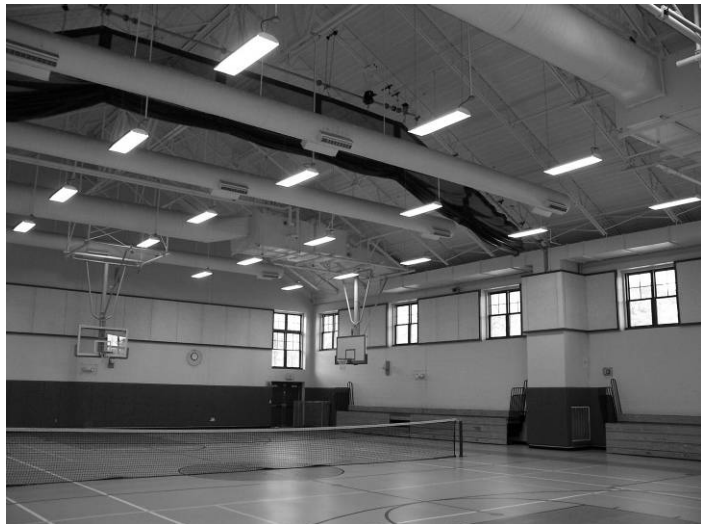
## 3. Install T5 “High Bay” Fixtures.

In the gymnasiums of many schools, replace the existing Metal Halide fixtures with T-5, High Output lamps and appropriate ballasts as shown at right. This is new technology and the benefits of T-5s over traditional HID fixtures are well documented. In addition to the energy savings, the improvement in light quality will be significant. In several locations (Memorial Intermediate School being the worst case), existing Metal Halide lamps are nearing the end of their life and have faded to roughly 65% of their original light output. Along with the T5 fixtures, a ceiling mounted occupancy sensor is an absolute must and will essentially double the energy savings. Rebates from Narragansett Electric Company (NGRID) may be available for selected equipment with pre-approved applications.

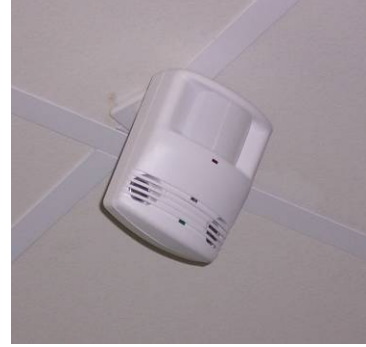
#### 4. Occupancy Sensors.

All classrooms, rest rooms, and offices should have an occupancy sensor similar to the one shown at right. These are proven energy savers. There are a number of varieties and manufacturers of these devices but the most important criteria should be two sources of detection – IR and UV – which most quality devices employ.

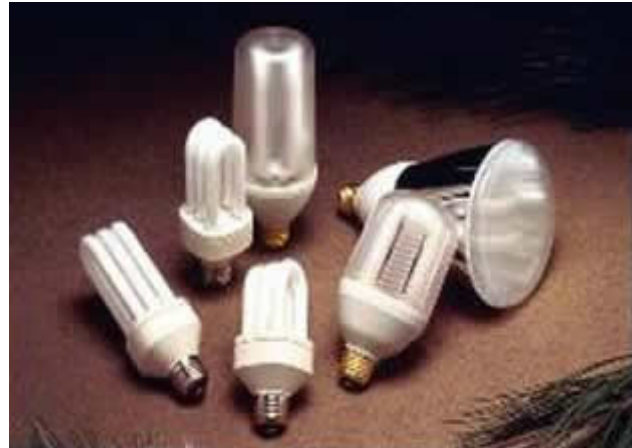
Throughout all facilities, traditional and ceiling mounted “spot” light incandescent fixtures and bulbs are everywhere. These generally range from 120 to 65 watt incandescent. All these lamps are inefficient, short-lived resulting in undue labor expenses, and generate an excessive amount of heat causing the cooling and ventilation systems to work harder than necessary. All of these problems add up to “very expensive.” Compact fluorescent lamps (CFLs) have evolved to a level where they are warm in color, are dimmable, use about ¼ the energy, give off ¼ of the heat given off by incandescent, and last 28 times longer, greatly reducing labor and maintenance.

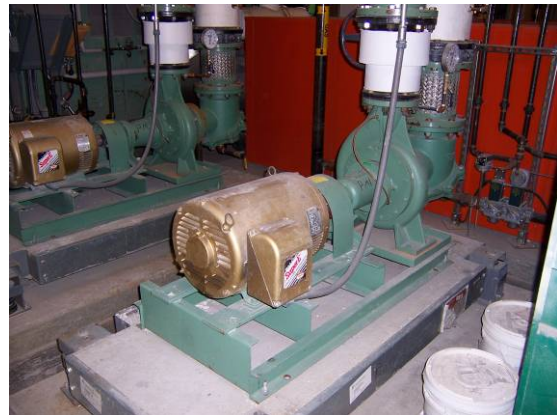
Virtually all of the electric motors currently in use are of standard efficiency. Premium efficiency motors are generally 5 to 10% more efficiency which results in a significant reduction in electric expenses. Motors such as those on the boiler circulation pumps which are 81% efficient run about 3000 hours per year. The cost of replacement with premium efficiency motors will be realized in energy savings in roughly two years.

Note: the greatest savings from this ECO will be realized when existing motors are replaced upon burnout, not via wholesale replacement.

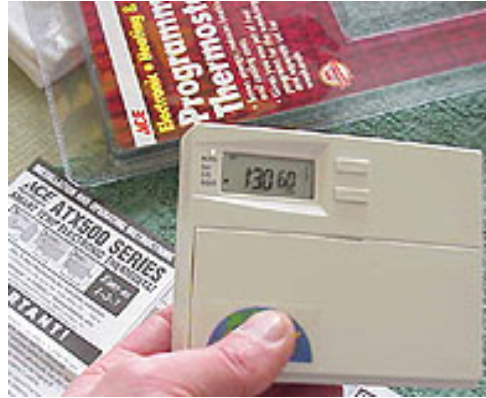
There is an Energy Management System in place at the High School but it is reported to be under utilized. For the balance of the facilities, the only significant energy controls in place are the facility operators. Heating, cooling, ventilation, and lighting are all operating without automatic controls. This practice becomes problematic and expensive when systems are inadvertently left “on” during “off” time periods. Frequently in facilities without automated controls, exhaust fans, heating and cooling devices, and other equipment are not controlled and run 24/7 even during periods when they could be turned off. Even a simple EMS will eliminate this uncontrolled practice.

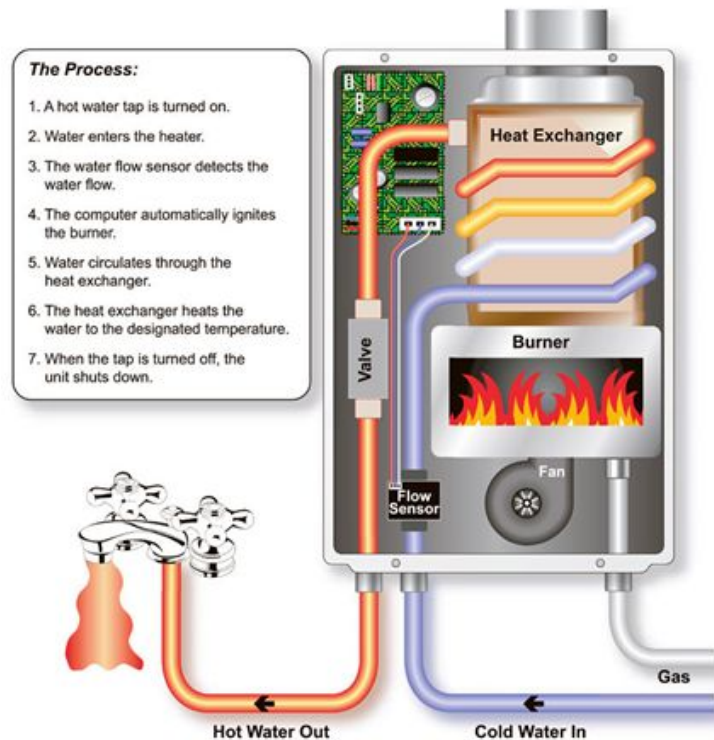
### **How Does a Tankless Water Heater Work?**

Replace existing hot water heaters with tankless DHW units. Installing a tankless water heater would eliminate the need to keep the existing electric hot water tanks “on” 24/7. These economical devices would easily handle the domestic hot water needs of the facility.

Note: the greatest savings from this ECO will be realized when the existing electric hot water heaters are replaced at the end of their useful life, not via wholesale replacement.

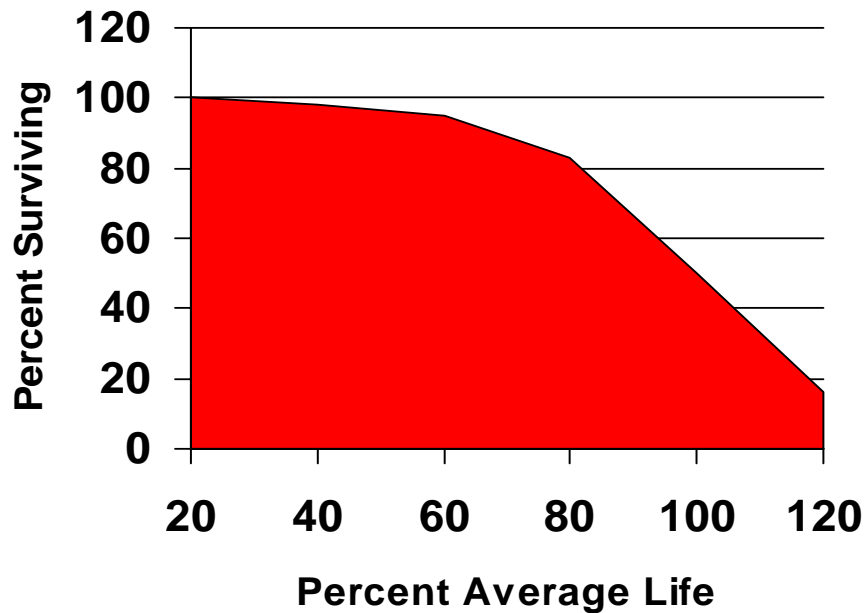
### **Typical Fluorescent Lamp Mortality Curve**

Studies have demonstrated the economic wisdom of conducting a group relamping at this point, thus avoiding increased labor expenses involved with changing random burnouts of ever increasing frequency after the 75% point.

All CFLs should also be changed at the same time. The recommended replacement lamp/ballast would be a “super” T8.

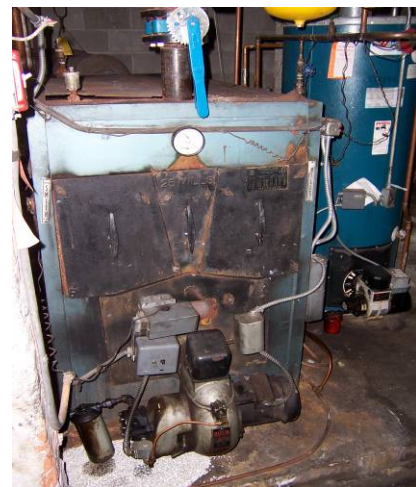
Currently, a variety of gas and oil fired boilers serve the schools in Central Falls. The aging oil fired boiler in Feinstein School shown at right should be replaced ASAP. Other boilers are almost new and others and somewhere in between. At the end of their useful lives, all boilers should be replaced with full condensing hydronic gas fired models. Boilers manufactured and sold by Viessmann or Buderus are recommended.

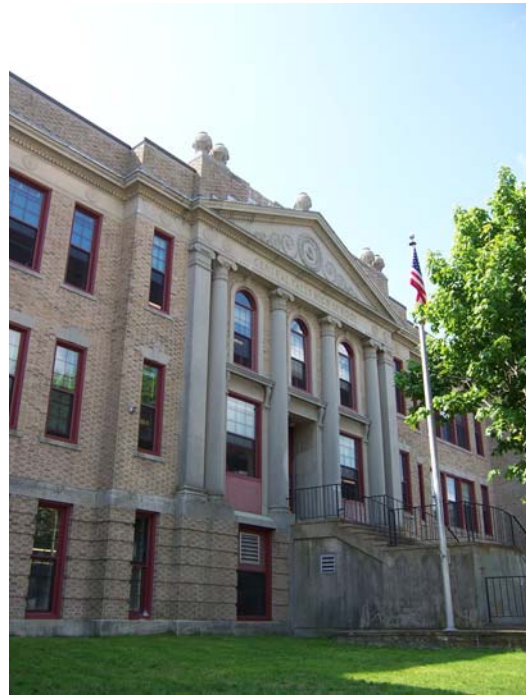
The building is essentially two facilities, the old section of 1929 vintage and the “new” section, built in 1974. There is an EMS which offers some degree of control for HVAC. Due to actuator failures, some of the controls have been over ridden. Heat and hot water are provided by a variety of sources. In the new section, electric unit ventilators heat the perimeter of the building while ancient RTUs handle the center or core areas. These RTUs are failing and need to be replaced. Hot water comes from the gym penthouse where two 20 year old Lockvar gas fired boilers generate hot water. Additionally, the kitchen (very new) has its own DHW boiler. For the old section, heat is steam heat generated via two boilers in the basement. A separate DHW tank is in the same area. The doors and windows are in reasonable shape. Lighting is primarily T8s and exits are LED. The gym and library are illuminated via metal halide sources. The Auditorium is lit by 300w incandescent bulbs.

<b>Description:</b>	<p>The existing two RTUs serving the core classrooms are obsolete and in an advanced state of disrepair. Further, they do not provide adequate ventilation.</p> <p>The existing 23 Nesbitt unit heat/ventilators in the perimeter classrooms are in disrepair, spare parts are not available, and are expensive to operate.</p>
<b>Recommendation:</b>	<p>Replace with High Efficiency HVAC units. Size large enough to provide heat and ventilation to the perimeter classrooms as well.</p> <p>Provide ductwork to perimeter classrooms.</p> <p>Remove old RTUs and 23 Nesbitt unit heat/ventilators</p>

1. Remove existing 23 Nisbett electric unit ventilators (shown at right). Recommend the installation of ductwork in the ceiling connecting to the two new RTUs on the roof, over the core classrooms. This ductwork will provide heat and ventilation.

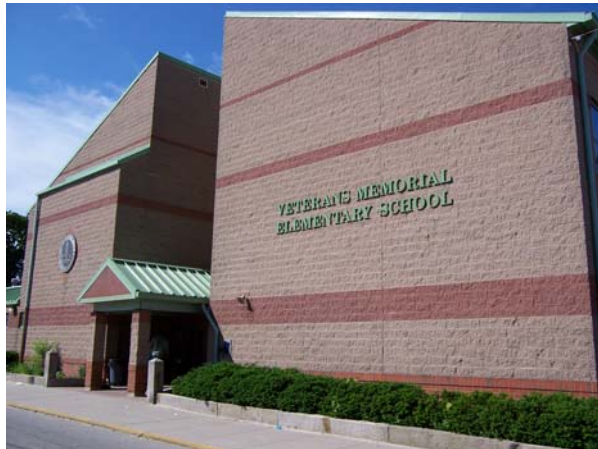
This three story brick and block building houses the grades 1 thru 5 of the Central Falls School District. From an energy standpoint, it operates from 6a to 10p during the school year and 7a-4p during the summer.

The 63,100 square foot building is sixteen years old. Heat and hot water are provided by gas equipment, the DHW tank being relatively new. The forced hot water heat is provided by 8 Hydro-therms, 16 years old. Water is circulated by two standard efficiency Baldor motors. Three 5 ton Trane units take care of heat and ventilation for the center core areas of the building.

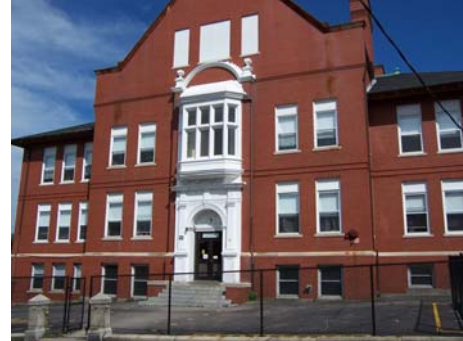
The 18,700 square foot building was built in 1889 but is in good shape. Heat and hot water are provided by gas equipment, the DHW tank being relatively new. The forced hot water heat is provided a new Thermific Boiler, reported to be in excellent shape and operating very well. Water is circulated by two standard efficiency Baldor 7.5 HP motors. One 5 ton York RTU units take care of cooling and ventilation for the registration offices. The registration offices have been recently renovated with suspended T8 fixtures.

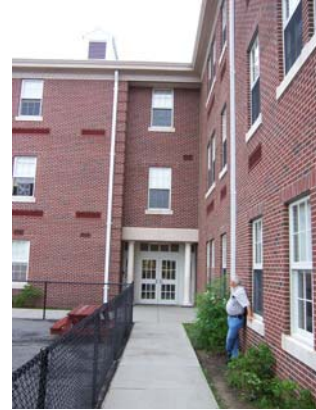
The 51,243 square foot building is heated via gas hot water. The forced hot water heat is provided via two new Thermific Boilers, reported to be in excellent shape and operating very well. Water is circulated by two standard efficiency Baldor 7.5 HP motors. There is a split system AC unit in place to provide cooling to the offices. Hot water is provided via a

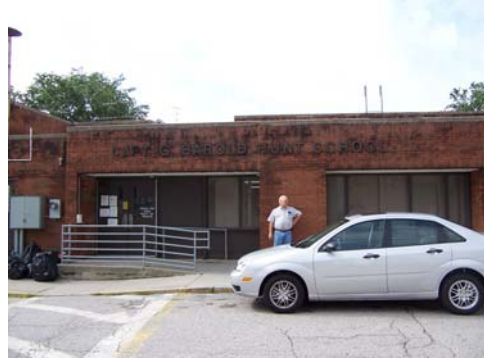
The 17,458 square foot building is heated via gas hot water. The forced hot water heat is provided via two new Thermific Boilers, reported to be in excellent shape and operating very well. Water is circulated by two standard efficiency Baldor 7.5

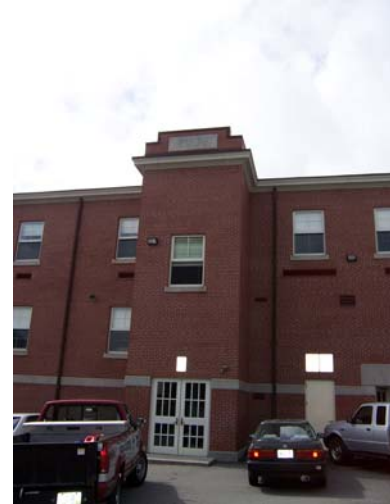
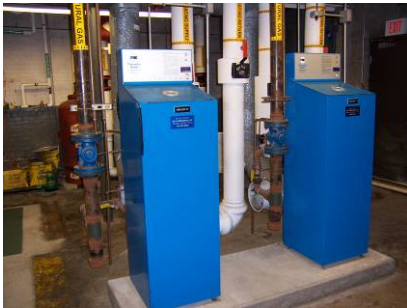
The 28,335 square foot building is heated via gas hot water. The forced hot water heat is provided via two new Thermific Boilers, reported to be in excellent shape and operating very well. Water is circulated by two standard efficiency Baldor 7.5 HP motors. Hot water is provided via a separate gas fired hot water tank which is located in the boiler room.

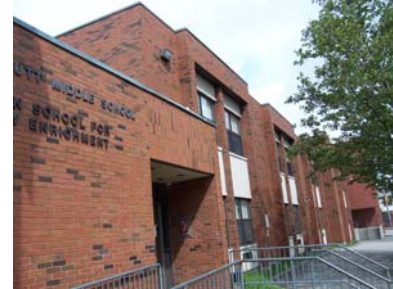
This two story brick and block middle school was constructed in 1976 and a significant addition was constructed in 1999. The facility is in excellent shape. From an energy standpoint, it operates from 6a to 10p during the school year and 7a-4p during the summer.

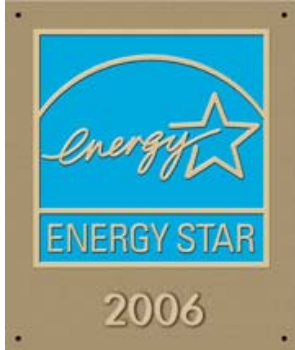
In an effort to receive an award, current data for the Administrative Building was input into EPA's Energy Star Building Portfolio Manager. The current score is 96! This facility is eligible for an Energy Star Award.

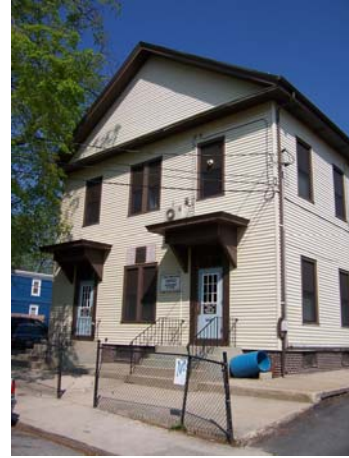
A second analysis was run, using after-ECM projections for savings. The score improved to 97%.

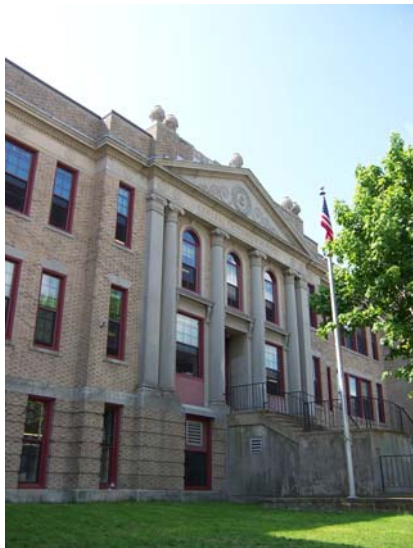
In an effort to receive an award, current data for the Central Falls High School was input into EPA's Energy Star Building Portfolio Manager. The current score is 17%.
